# SCHROEDER HOUSE RESTORATION CONDITION ASSESSMENT

SHEET **AP201**  
EXTERIOR ELEVATION SOUTH HOUSE  
04/20/21

Miller  
Dunwiddie  
millerdunwiddie.com  
100 Washington Ave South, Suite 500  
Minneapolis, Minnesota 55401 | 612 337 0000

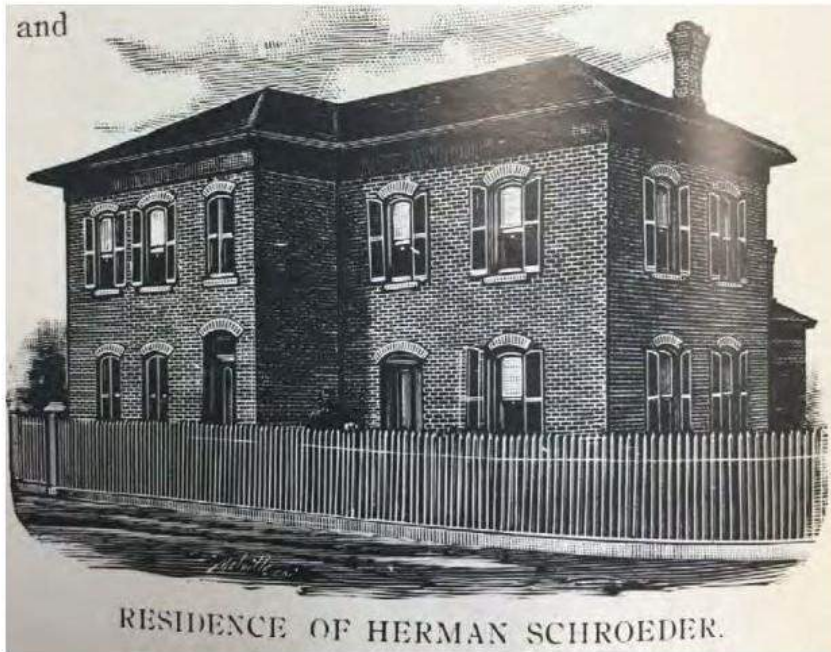
Image 1

SC-SPC-096 - - 1891 Drawing (Hinds 1891)

Per historic drawing of house wood curved top shutters flanked each upper window. See image 1. Typical all elevations.

Asphalt roof is in good condition. Original roof of house was wood shingle. See image 1.

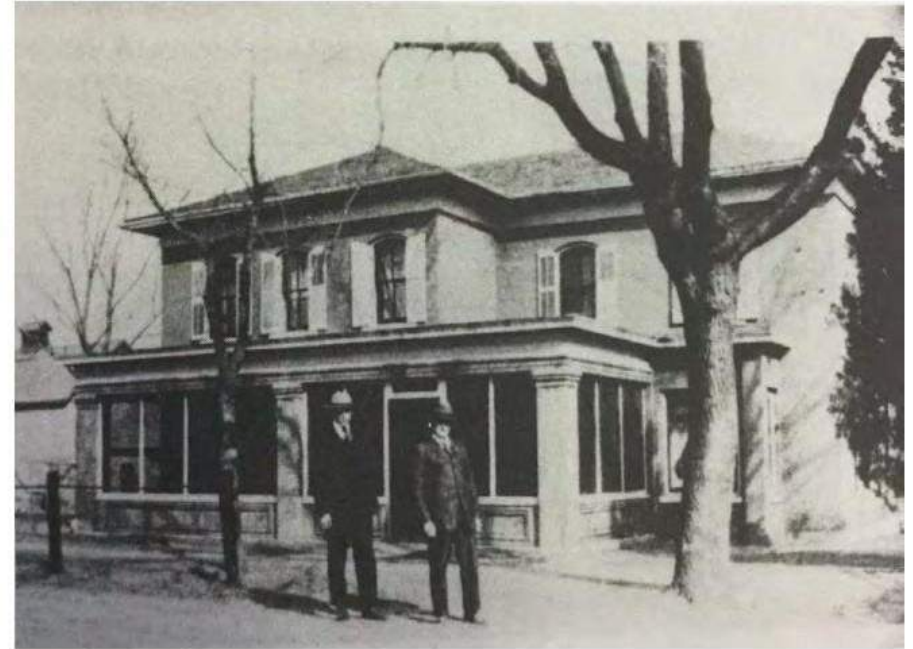
SC-SPC-096 - - Historical Photograph, Date Unknown (Huber et al. 1992:91)

Brick infill and wood windows/door between pilasters were additions to the porch. Recommendation to remove and restore to original porch fenestration with wood framed screens between pilasters. Typical at 2 front and each side bay. See Image 2

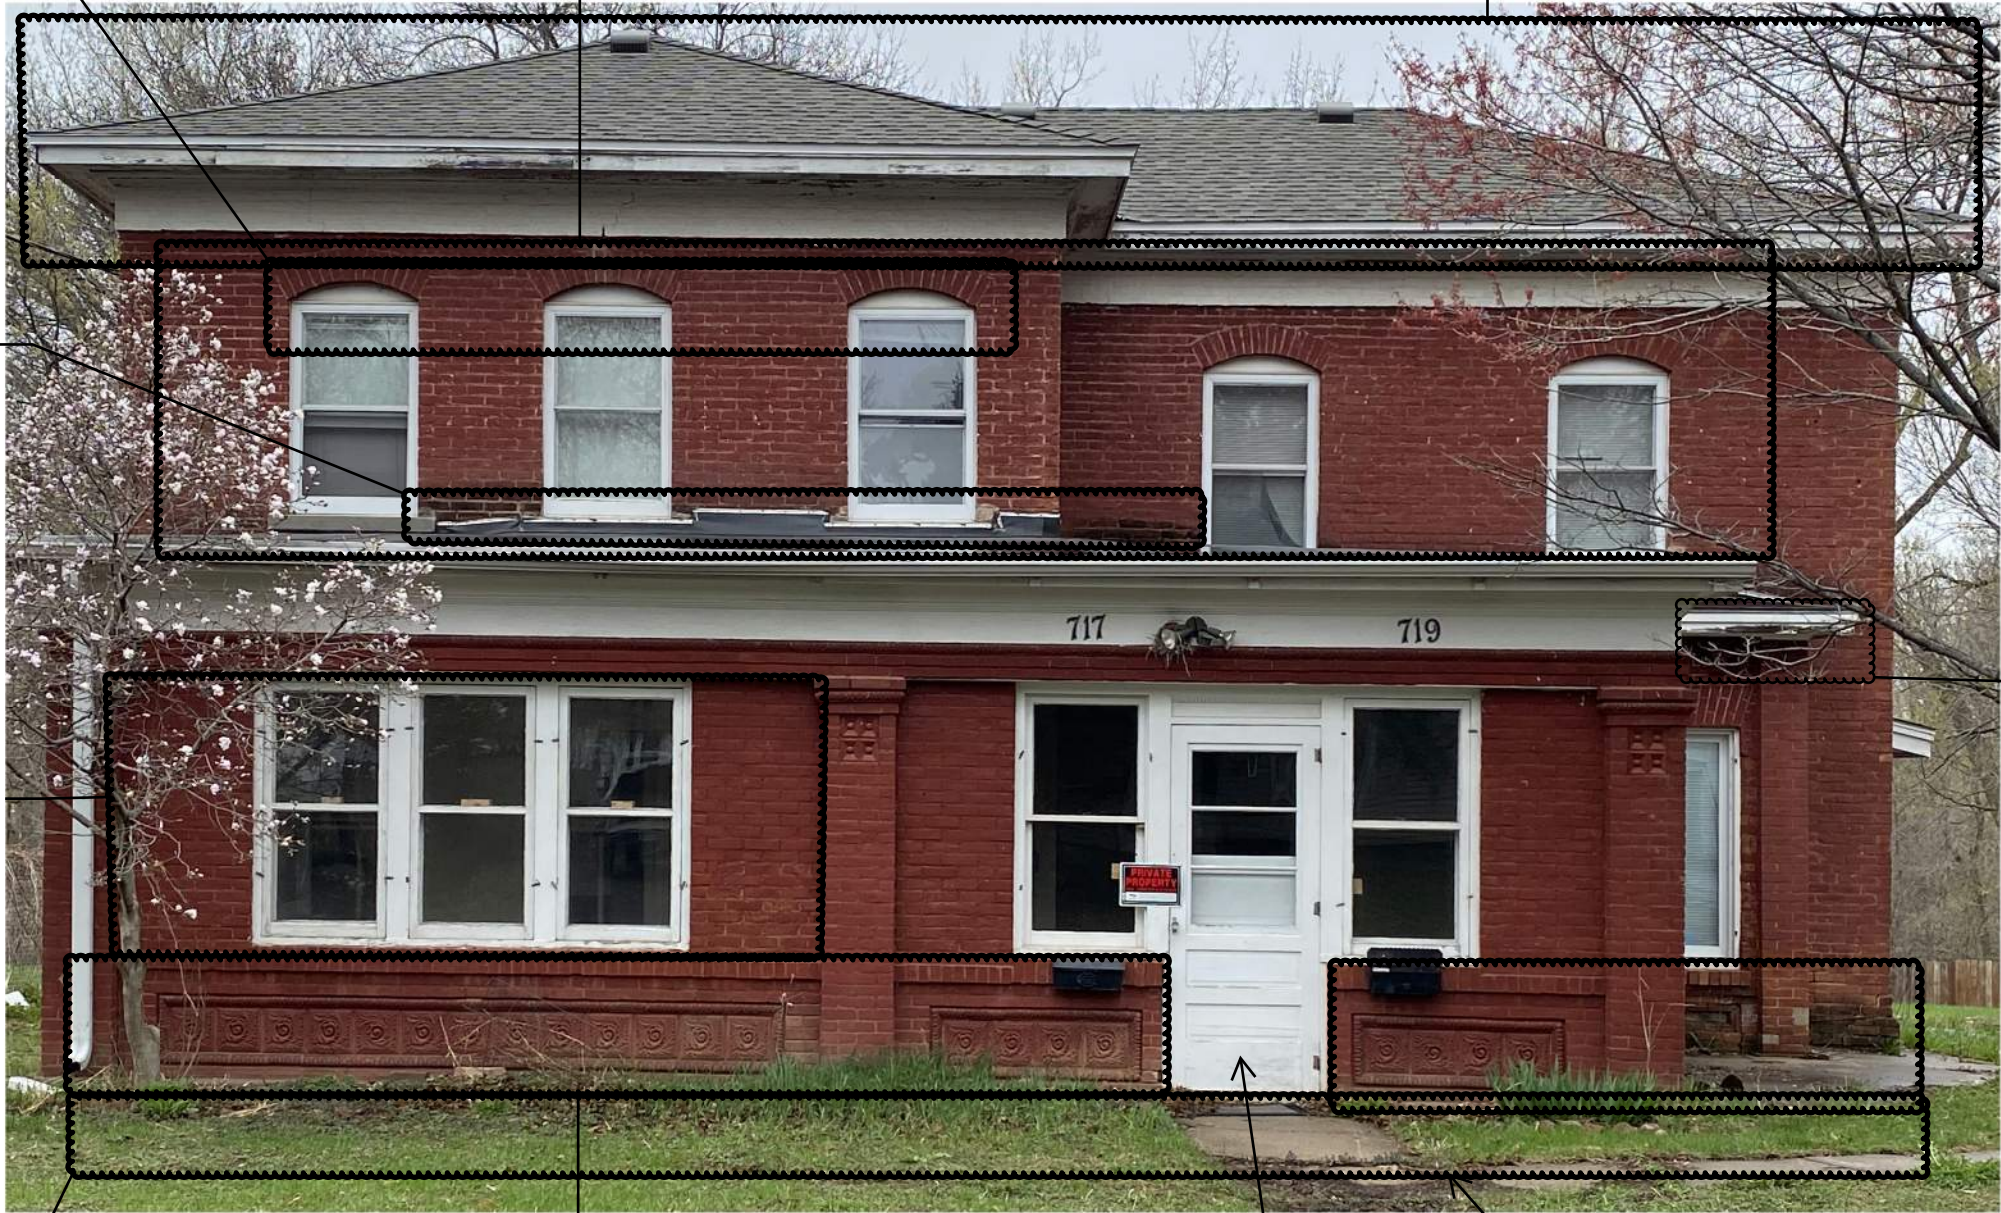
Windows are wood double hung with alum storms. Windows are in fair condition with some peeling paint particularly at sills. Original wood windows of house were arch topped to infill masonry opening. See Image 1. Typical all elevations.

Membrane roof is in good condition. Flashing related to roof work should be installed in mortar joint only with full reglet and should be continuous at entire edge of roof.

Grading at perimeter of house has settled causing the noted brick and mortar deterioration below the main level windows sills as noted. Correct grading. Typical all elevations.

Brick masonry and mortar joints have been stained. Clean staining from masonry with warm water only. Test prior to cleaning entire building. Detergent or other cleaning is not recommended of brick due to porous character of Shakopee Brick due to potential residue. Repoint deteriorated mortar and replace deteriorated brick masonry if unit is cracked or unit face is spalled more than 30%. Typical all elevations.

Wood fascia and soffits are in poor to fair condition with some wood deterioration and failing paint - typical all locations Remove and replace deteriorated wood and repaint. Remove and replace modern gutters and downspouts at porch and replace per Image 1. Typical all elevations.

Brick unit and mortar deterioration is present at all side of house and will require selective brick replacement and repointing of mortar joints. Typical all elevations.

Per historic image door was a framed screen door. Remove existing and replace with screen door

Settlement of side walk does not provide an accessible ingress or egress from building. Remove and replace to meet code.

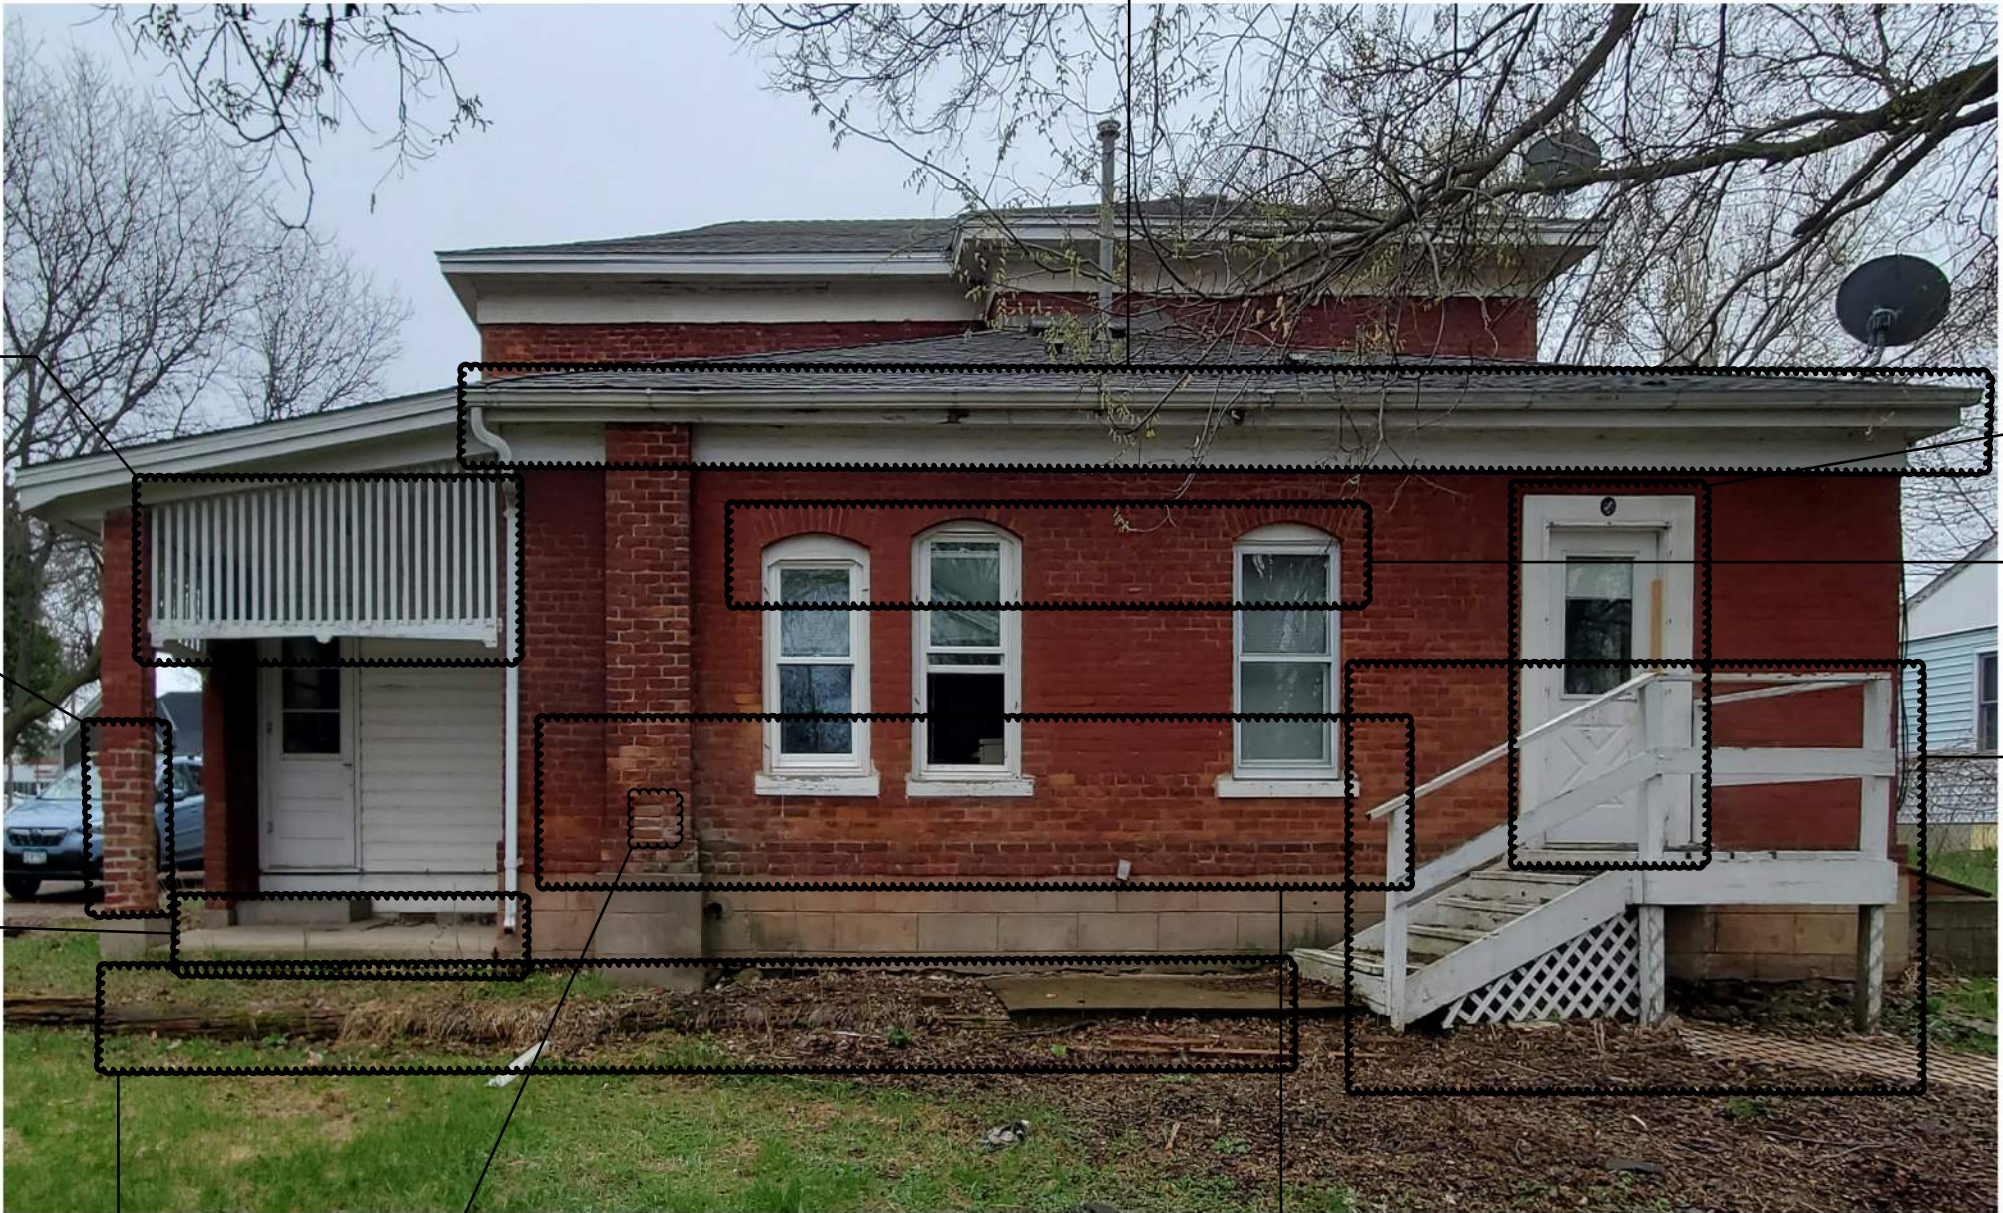
SHEET **AP202** Miller  
Dunwiddie

Gutter and wood fascia - See AP201

See AP201 for  
general note on brick  
masonry and mortar.

Wood screen. Prep  
and paint.

Inappropriate  
mortar  
replacement.  
Remove and  
replace.

Concrete step  
is not to code at  
a door.  
Concrete slab  
is in poor  
condition.

Alum clad door and trim.  
Exposed electrical box in  
trim head. Remove and  
replace with wood.

Windows - See AP201

Wood stair and landing is in  
poor condition. Remove  
and replace. See  
recommendations.

Grading - See AP201

Inappropriate brick infill.  
- remove and replace

Brick masonry and mortar deterioration - See AP201.  
Stone window sills are painted. Removal of paint could damage stone.  
In historic drawing - image 1, these are shown as brick.

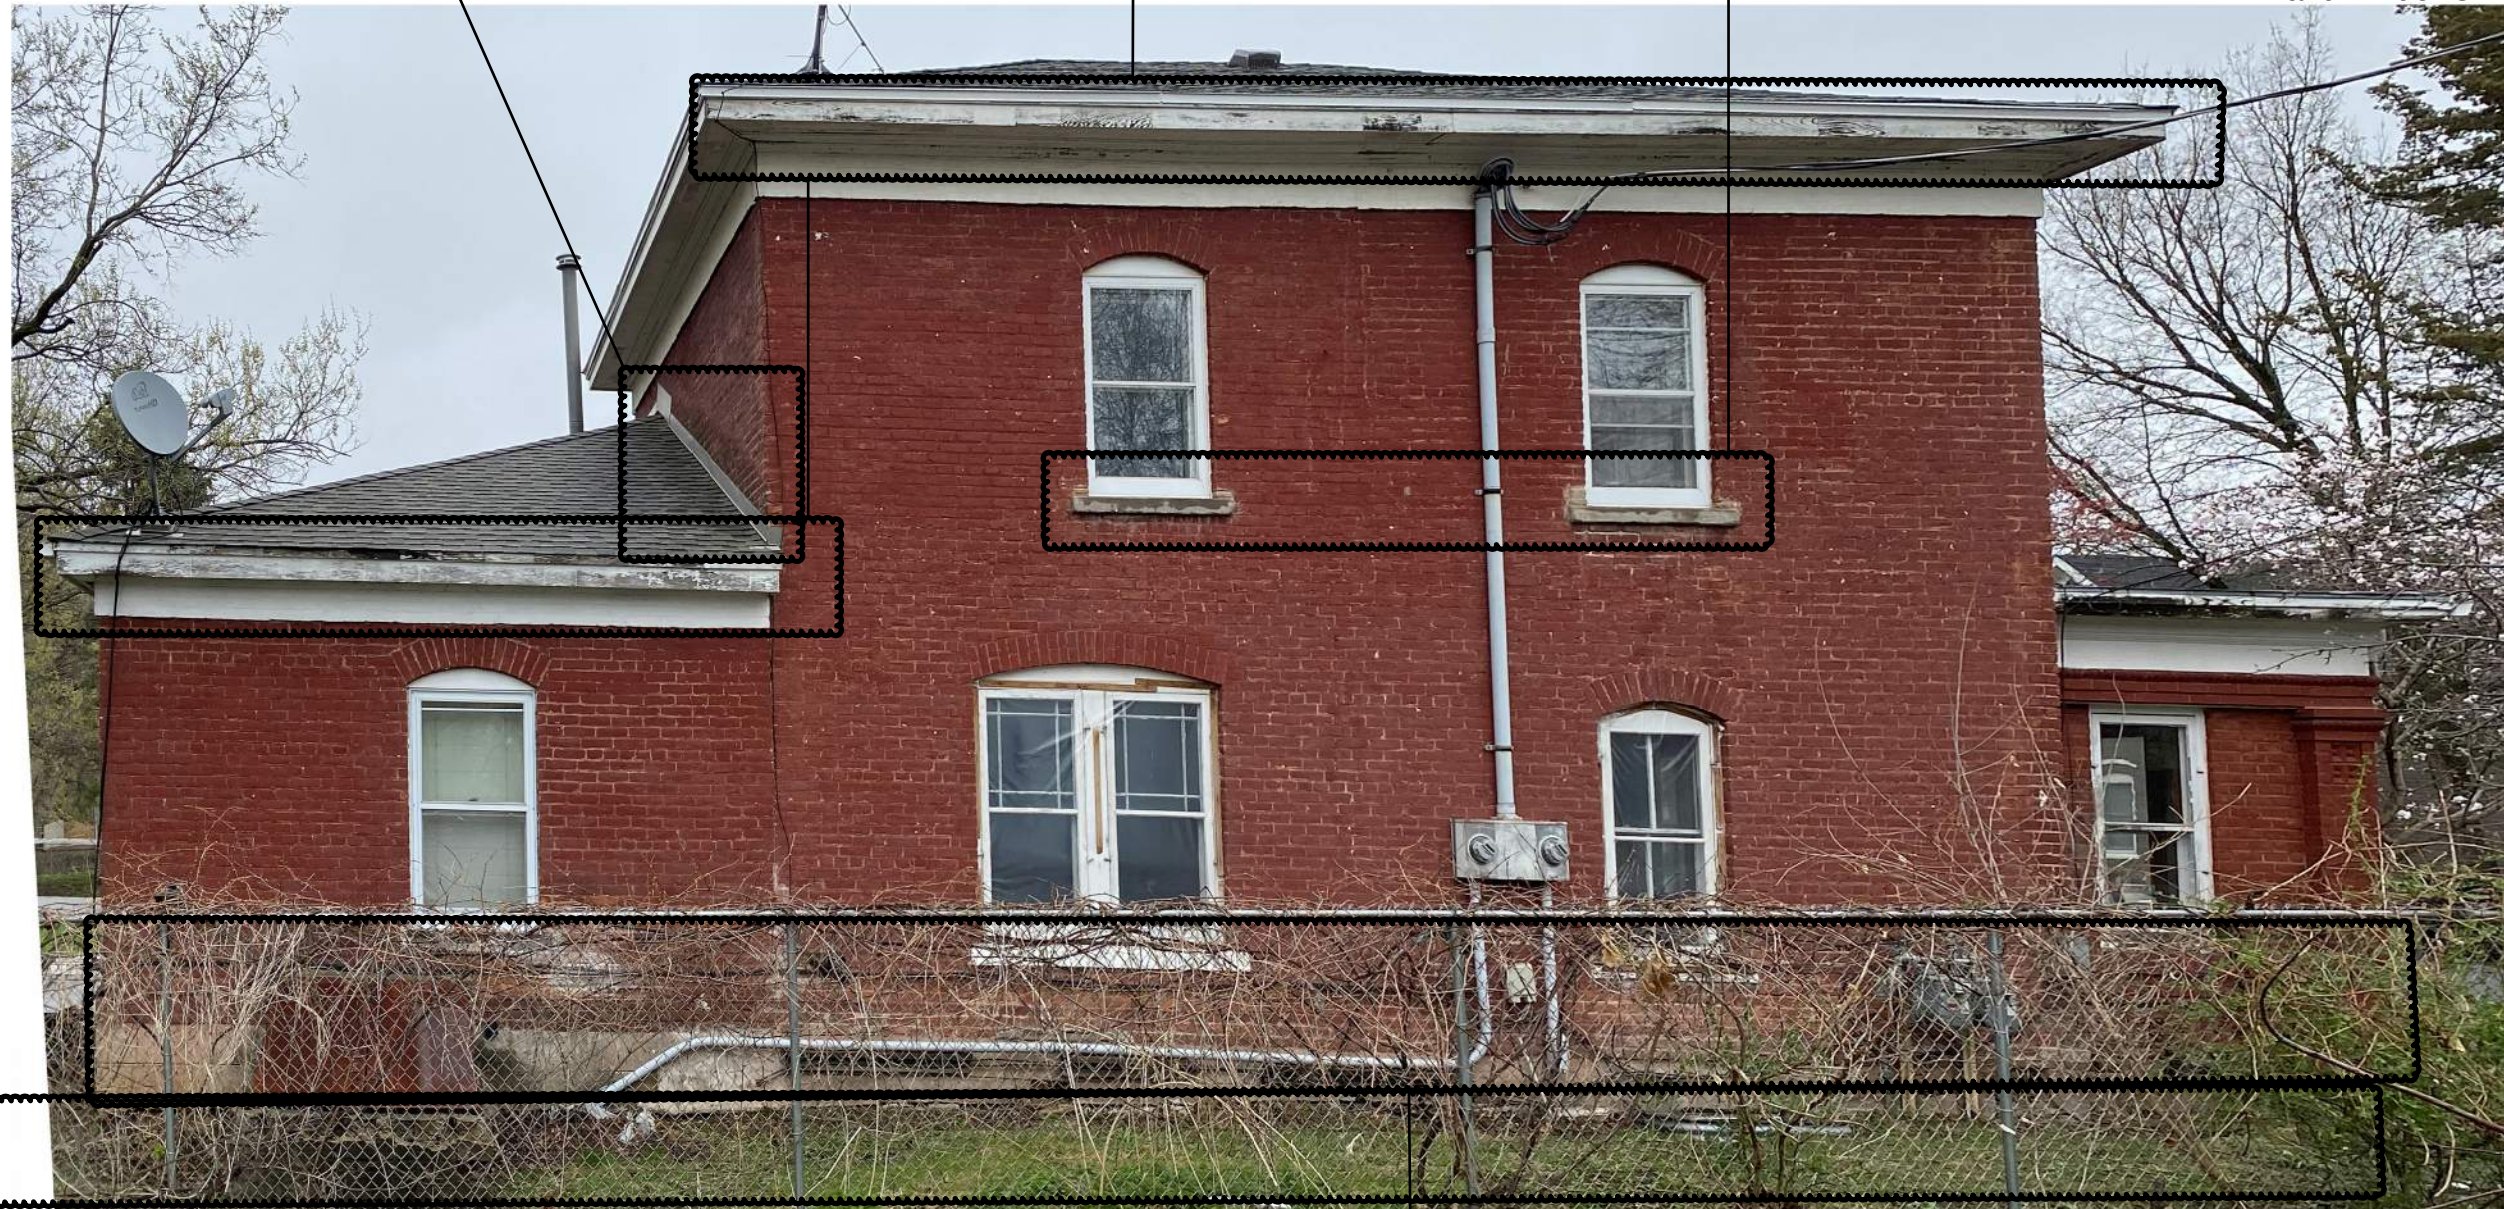
# SHEET **AP203**

Flashing is not detailed appropriately for condition. Remove and replace with stepped flashing within mortar joint with reglet.

Wood fascia and soffit - See AP201

Mismatched masonry repairs at window sills. Remove and replace.

See AP201 for general note on brick masonry and mortar and windows.

Grading - See AP201

Brick masonry and mortar deterioration - See AP201.  
Stone window sills are painted. Removal of paint could damage stone.  
In historic drawing - image 1, these are shown as brick.

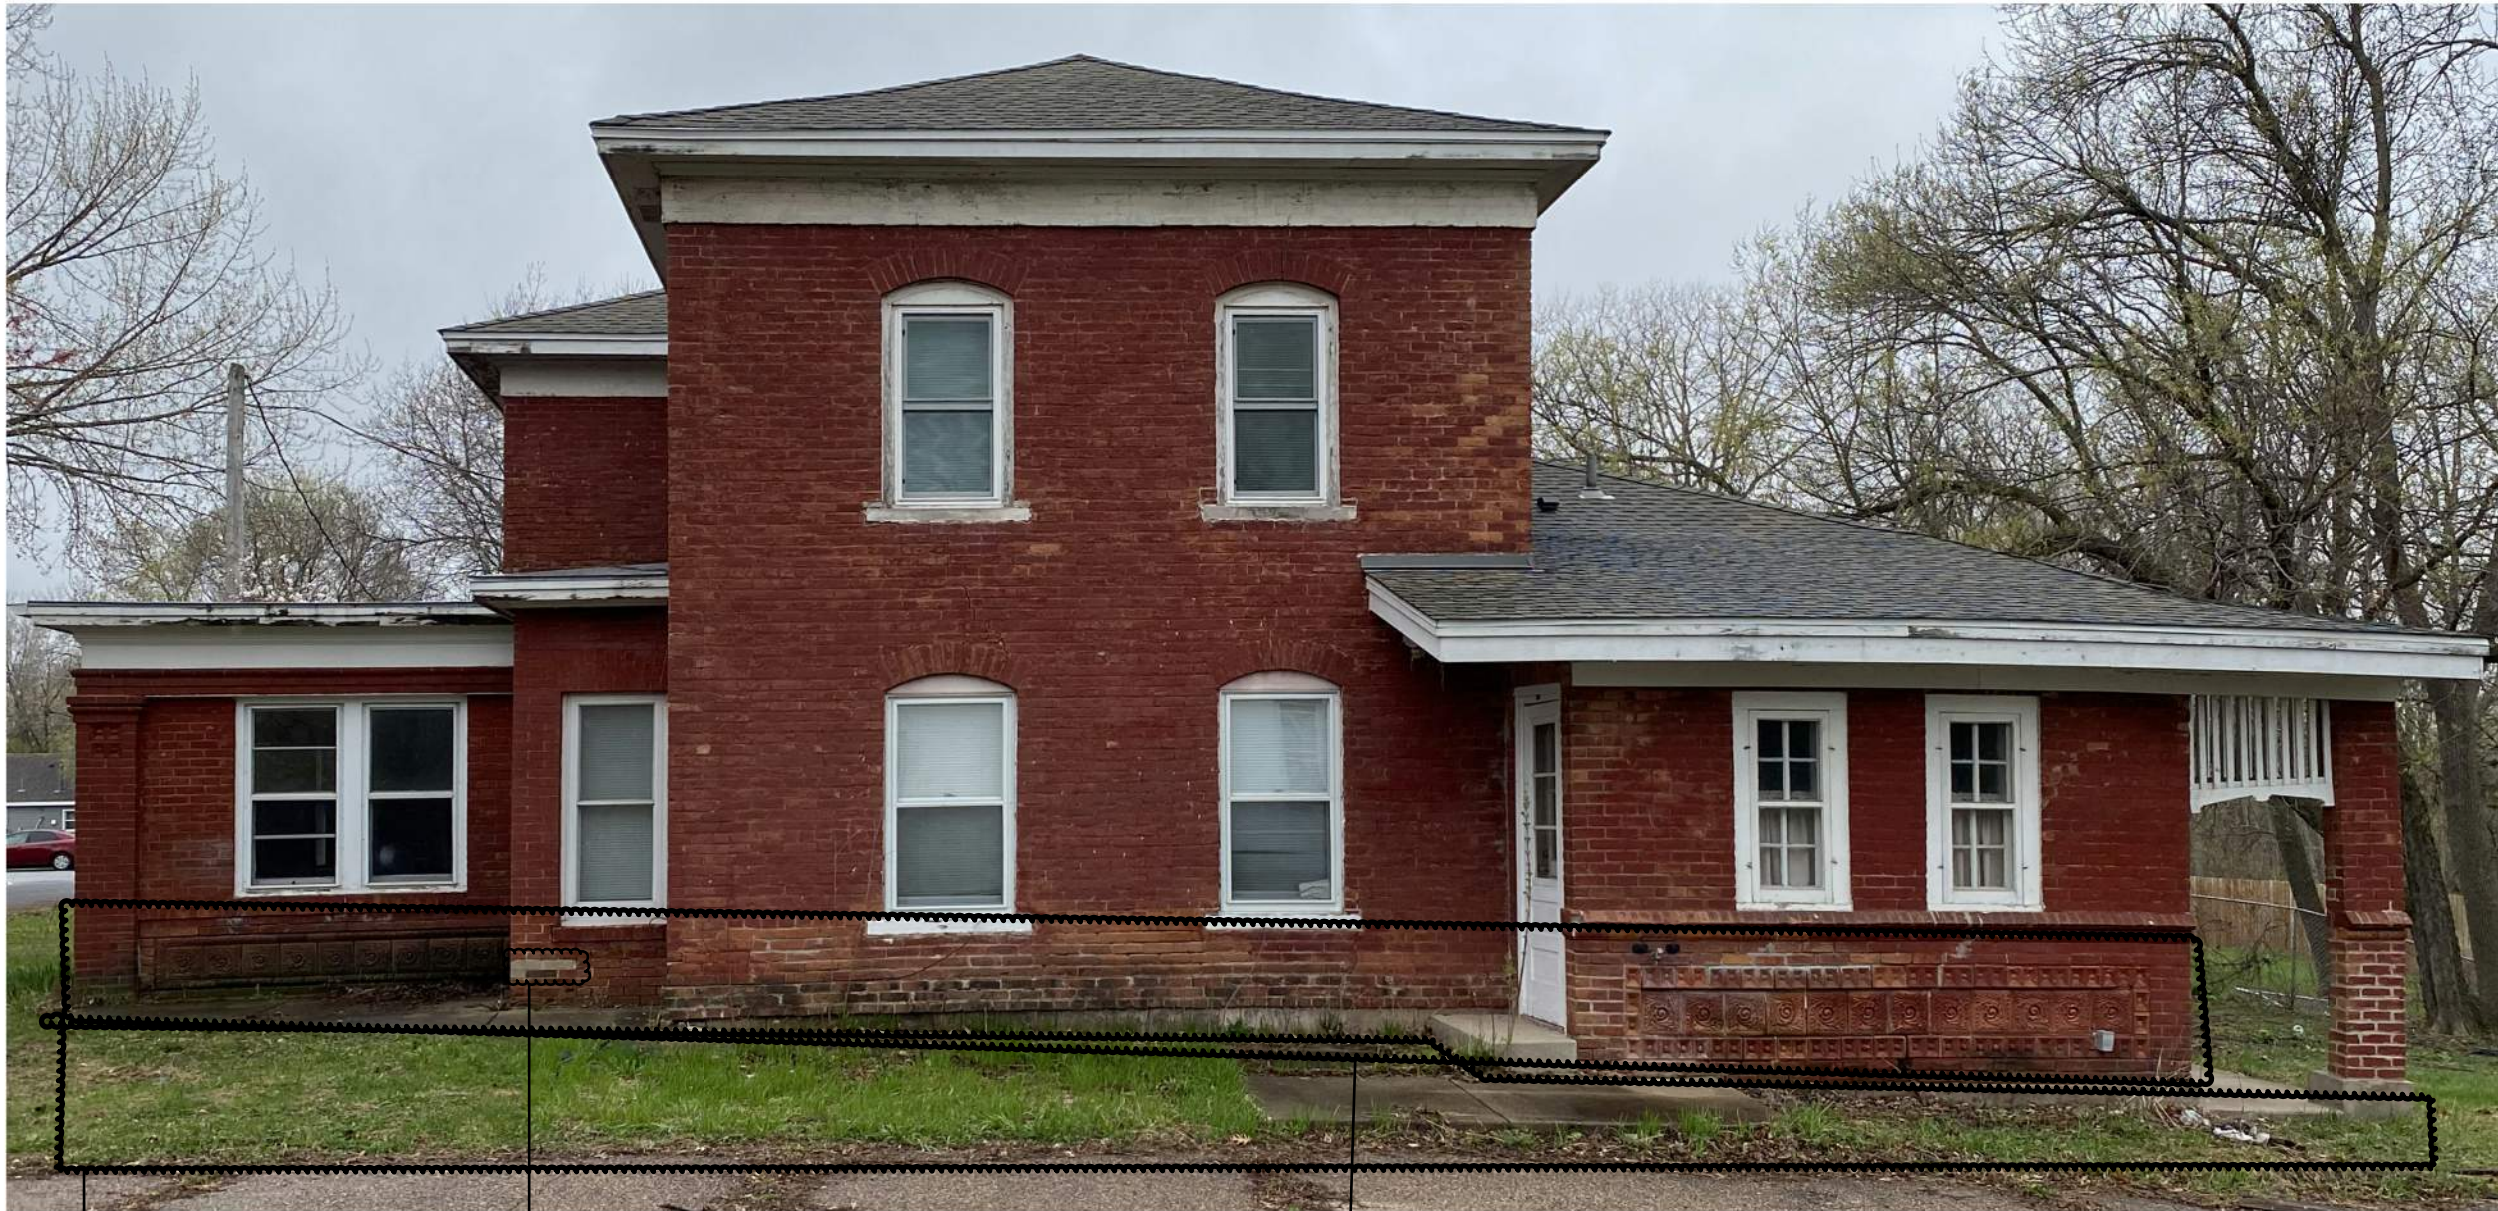
SHEET **AP204**  
EXTERIOR ELEVATION EAST HOUSE  
04/20/21

See AP201 for general note  
on brick masonry and mortar,  
window note and fascia note.

Grading and settled concrete  
slab are contributing to brick  
masonry deterioration at base  
of house

Inappropriate brick infill  
- remove and replace

Brick masonry and mortar deterioration - See AP201.  
Stone window sills are painted. Removal of paint could damage stone.  
In historic drawing - image 1, these are shown as brick.

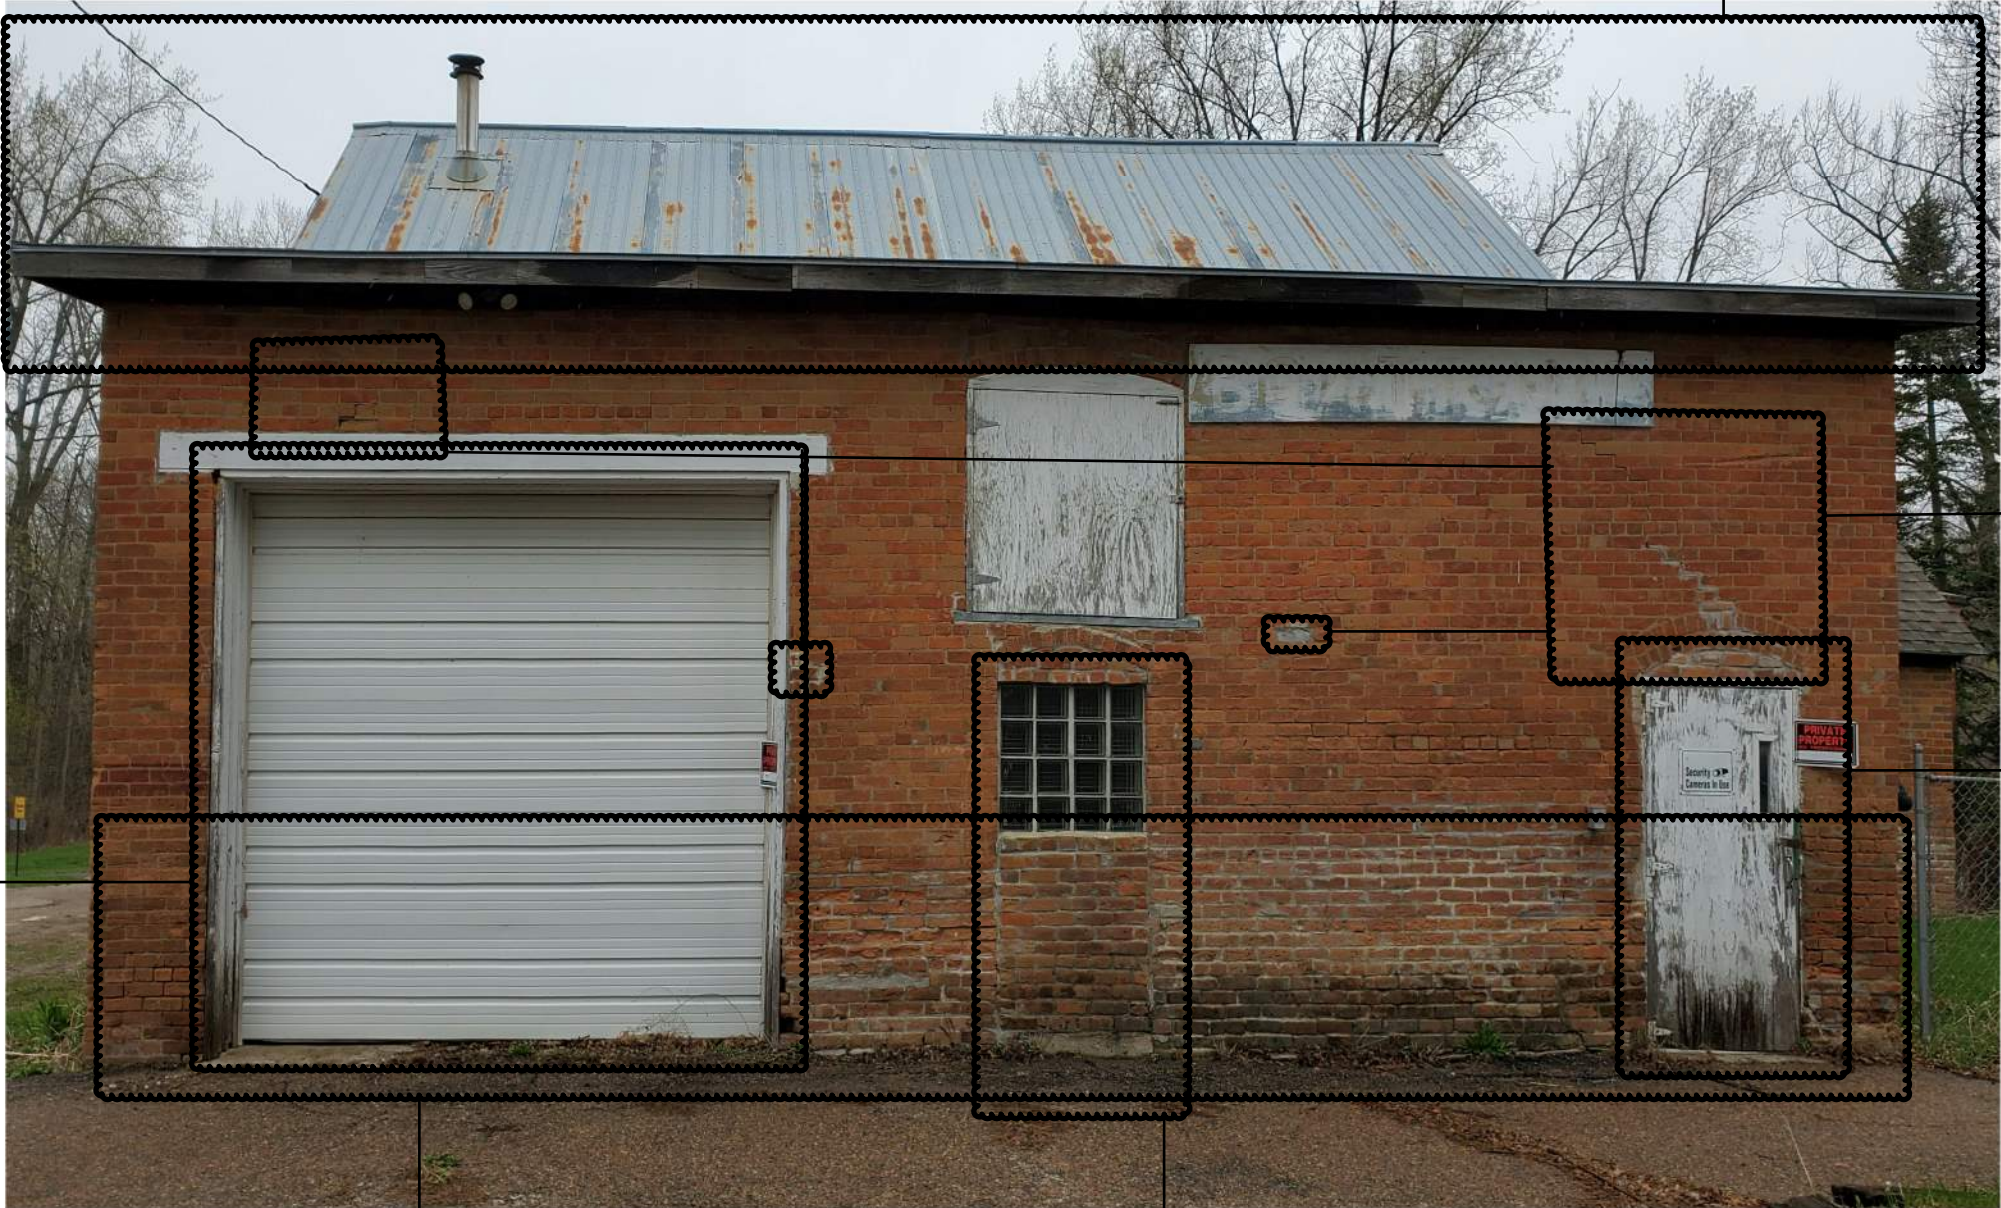
SHEET **AP211**  
EXTERIOR ELEVATION SOUTH WORKSHOP  
04/20/21

Metal roof is in poor condition. See Image 2 with Livery in distance. Roof appears to have been wood shingle.

Brick masonry and mortar joints are in fair to poor condition. Repoint deteriorated mortar and replace deteriorated brick masonry if unit is cracked or unit face is spalled more than 30%. Typical all elevations.

Cracked brick and inappropriately repaired brick.

Inappropriate infill at arch and wood door in poor condition

Alum overhead door with wood frame. Door is in good condition. Paint and wood of frame is deteriorated at sill to approx 30"

Deteriorated, missing and stained brick masonry and mortar due to settled grade and hardscape

Inappropriate brick and glass block at arch topped door opening

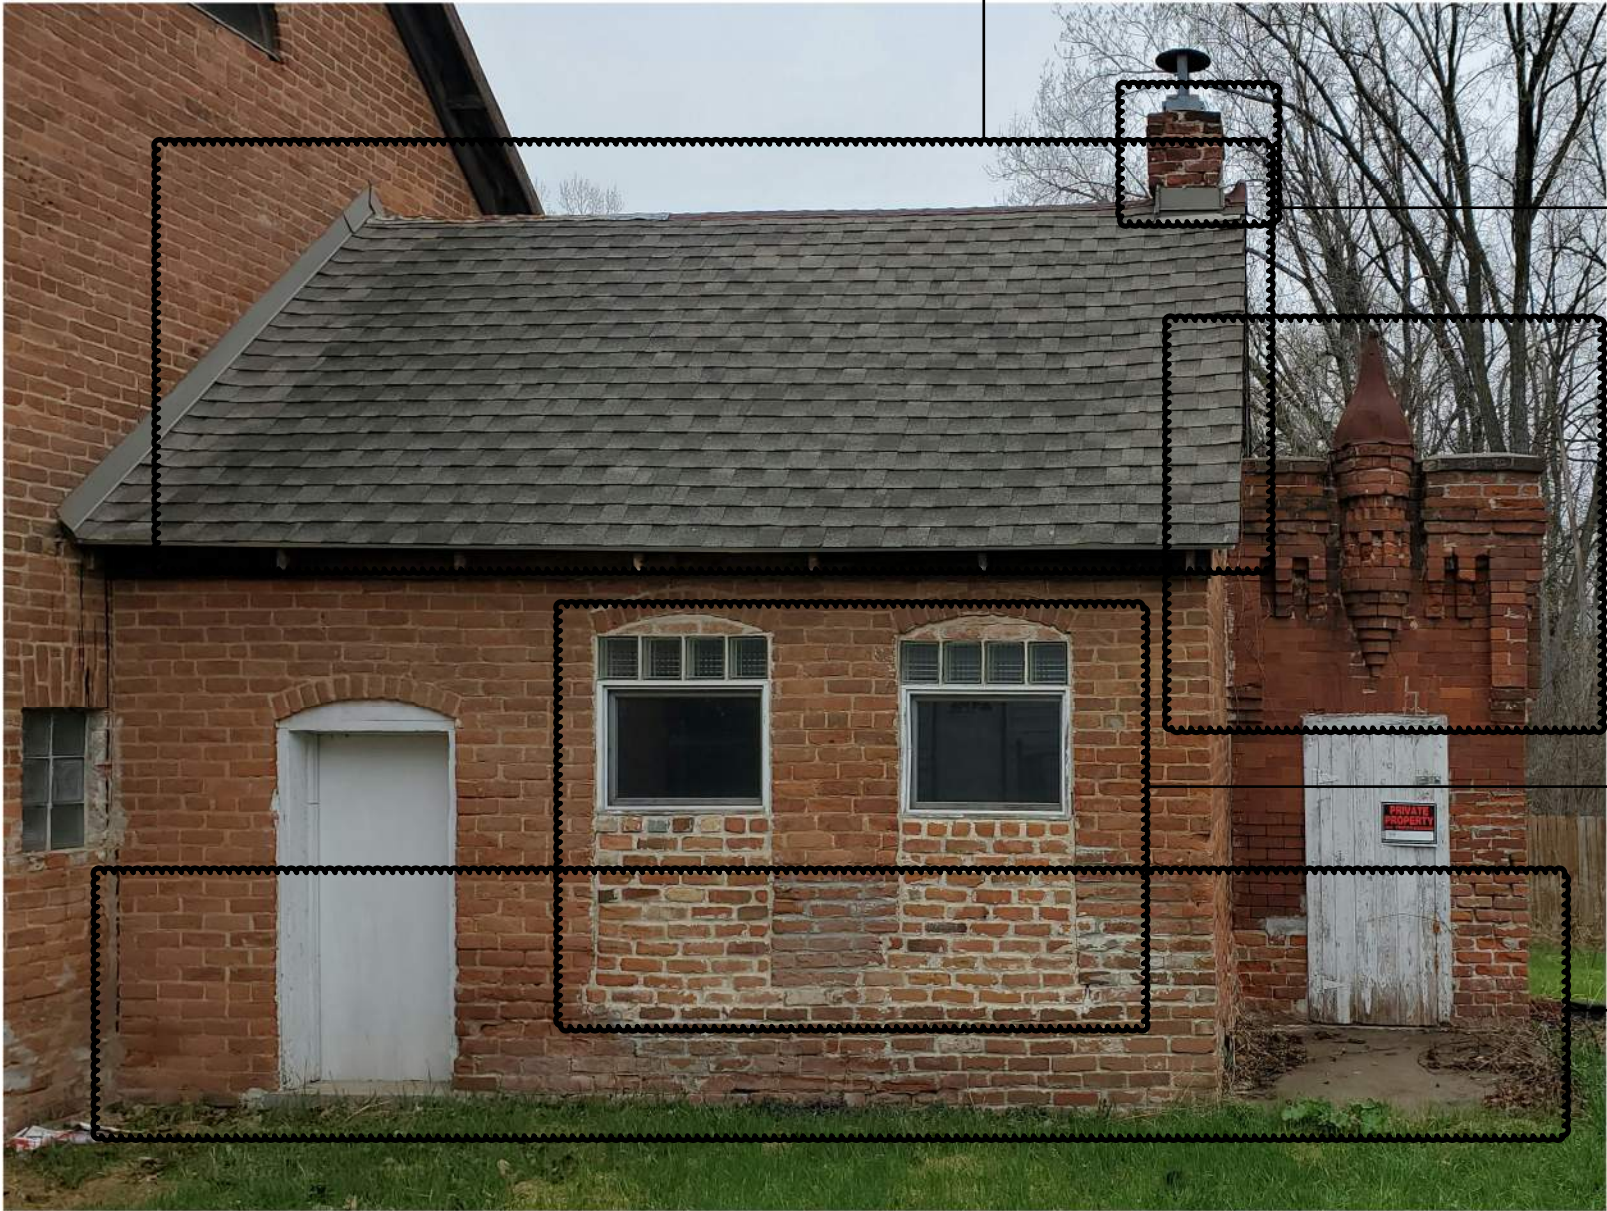
Original roof was likely wood shingle. Asphalt is in good condition.

See AP211 for general note on brick masonry and mortar.

Reconstruct chimney

Detailed brick cornice is in poor condition

Glass block, window and infill in original arched top openings

Masonry and mortar in poor condition

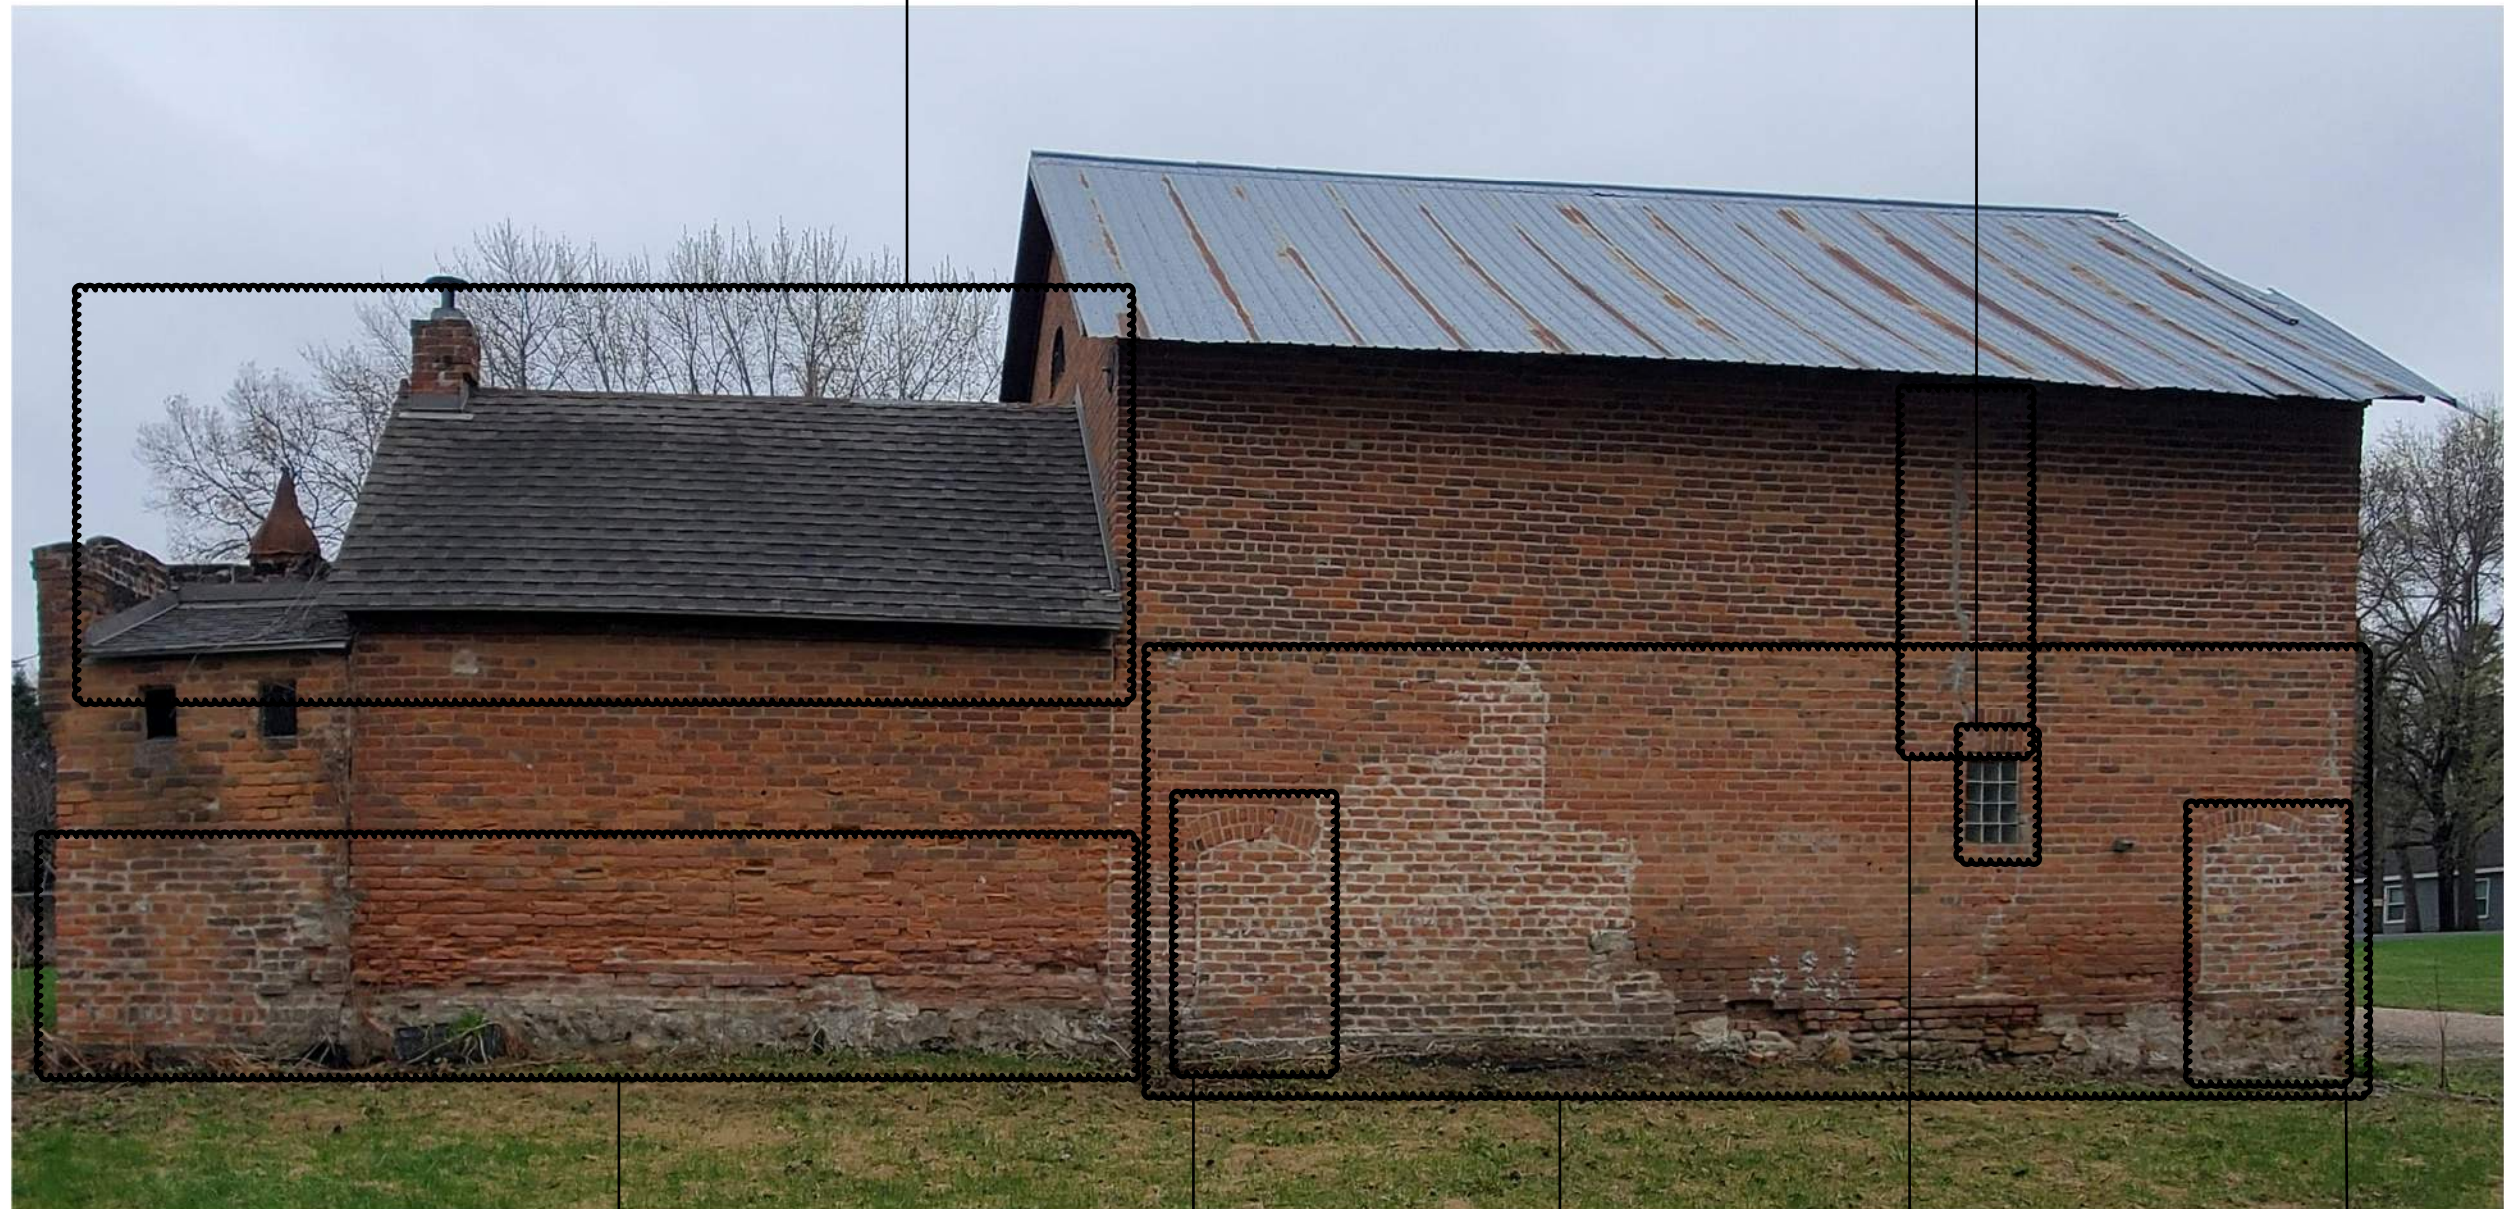
**SHEET A P213** Miller  
Dunwiddie  
EXTERIOR ELEVATION NORTH WORKSHOP  
04/20/21

See AP211 for  
general note on brick  
masonry and mortar.

See AP212 for roof  
note

Glass block infill at  
window opening

Brick masonry and mortar joints  
are in poor condition

Brick top opening with  
brick infill

Brick masonry and  
mortar joints are in  
poor condition

Cracked brick with  
inappropriate repair

Brick top opening  
with brick infill
