# SCHROEDER HOUSE RESTORATION CONDITION ASSESSMENT

SHEET **AP201**  
EXTERIOR ELEVATION SOUTH HOUSE  
04/20/21

Miller  
Dunwiddie  
millerdunwiddie.com  
100 Washington Ave South, Suite 500  
Minneapolis, Minnesota 55401 | 612 337 0000

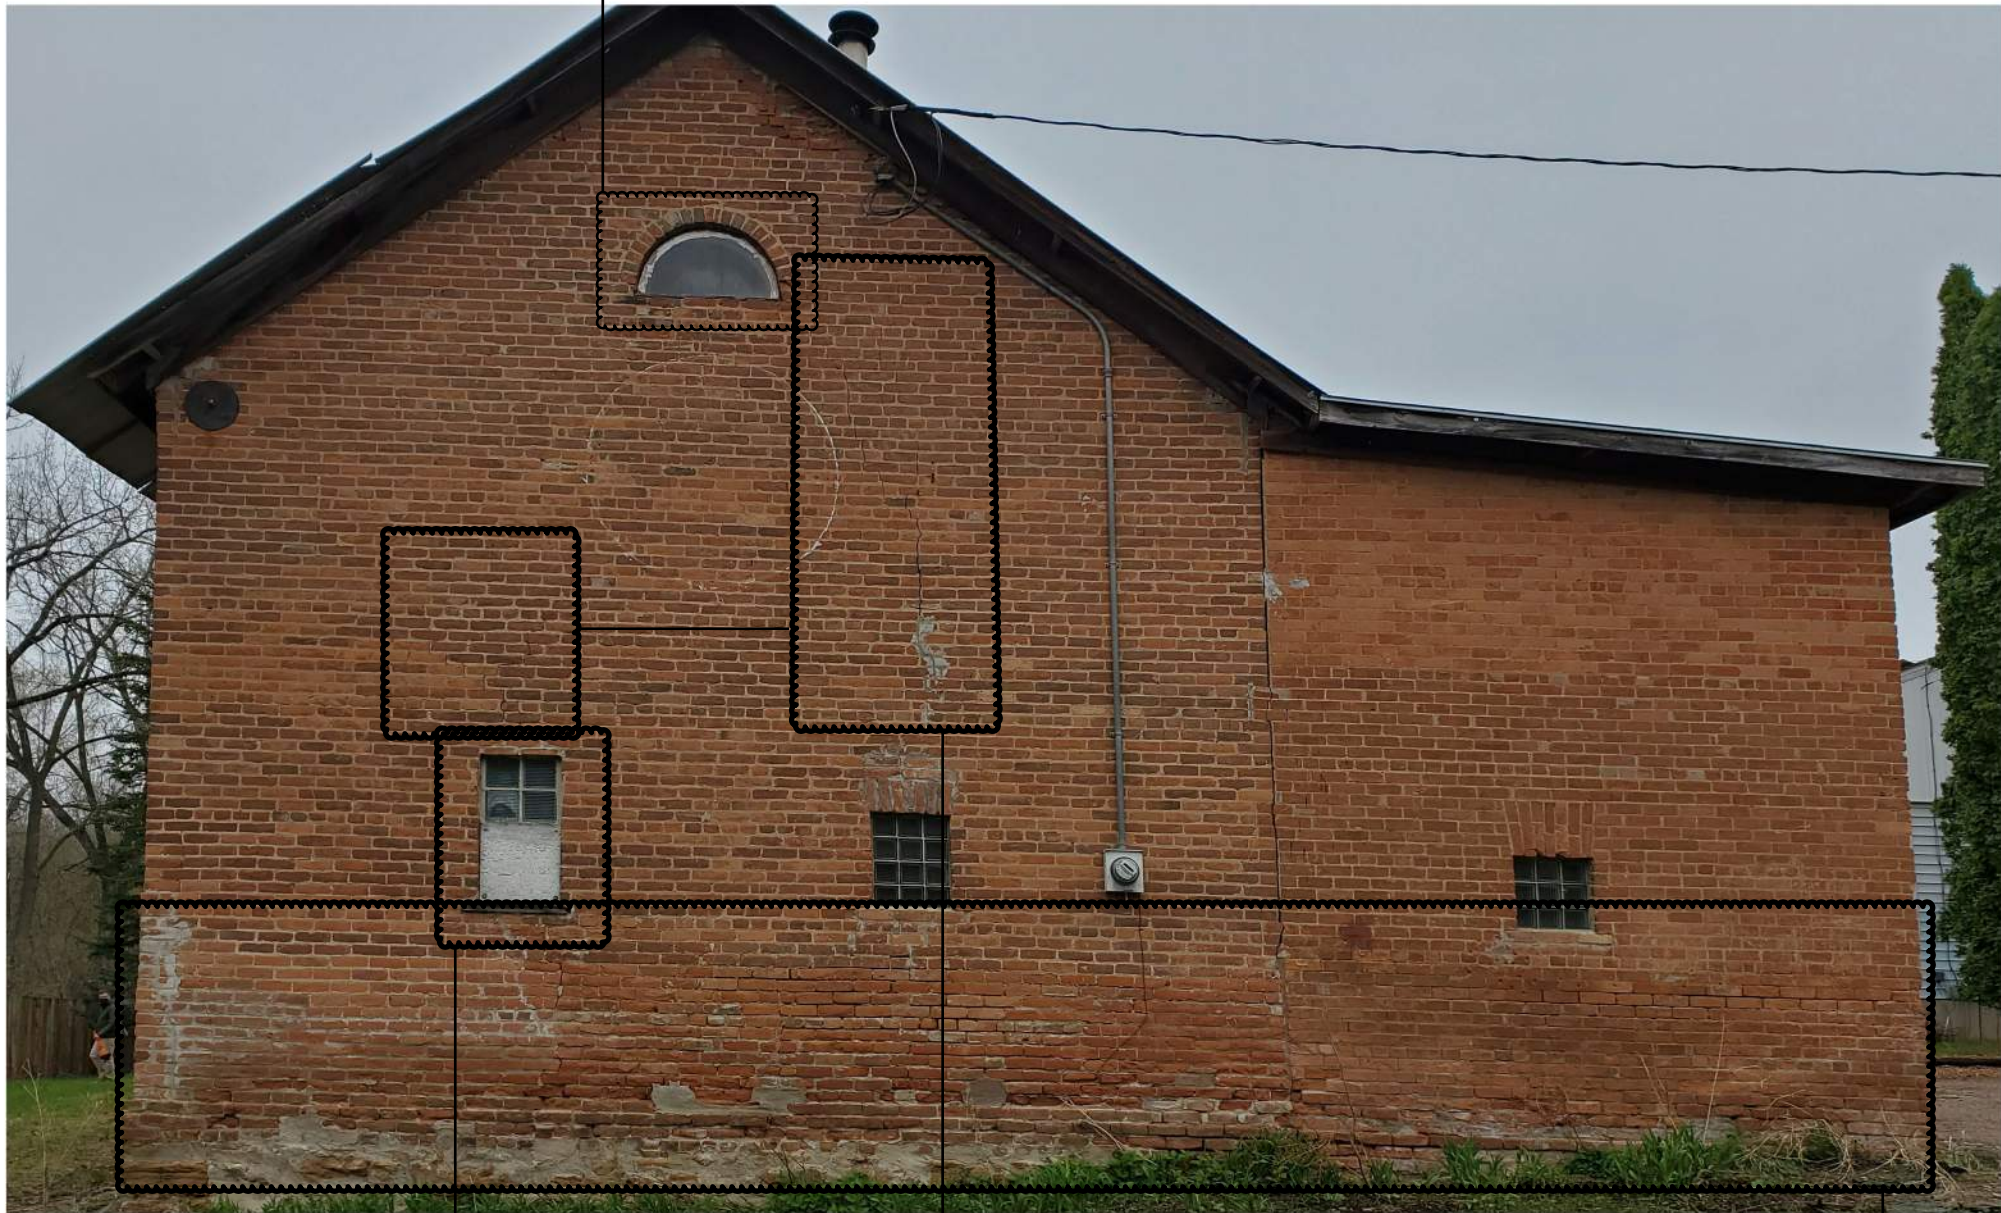
SHEET **A P214**  
EXTERIOR ELEVATION WEST WORKSHOP

plexiglass infill at  
arched opening

Glass block at  
openings - typical

Cracked and  
inappropriately repaired  
brick

Brick masonry and mortar joints in  
poor condition

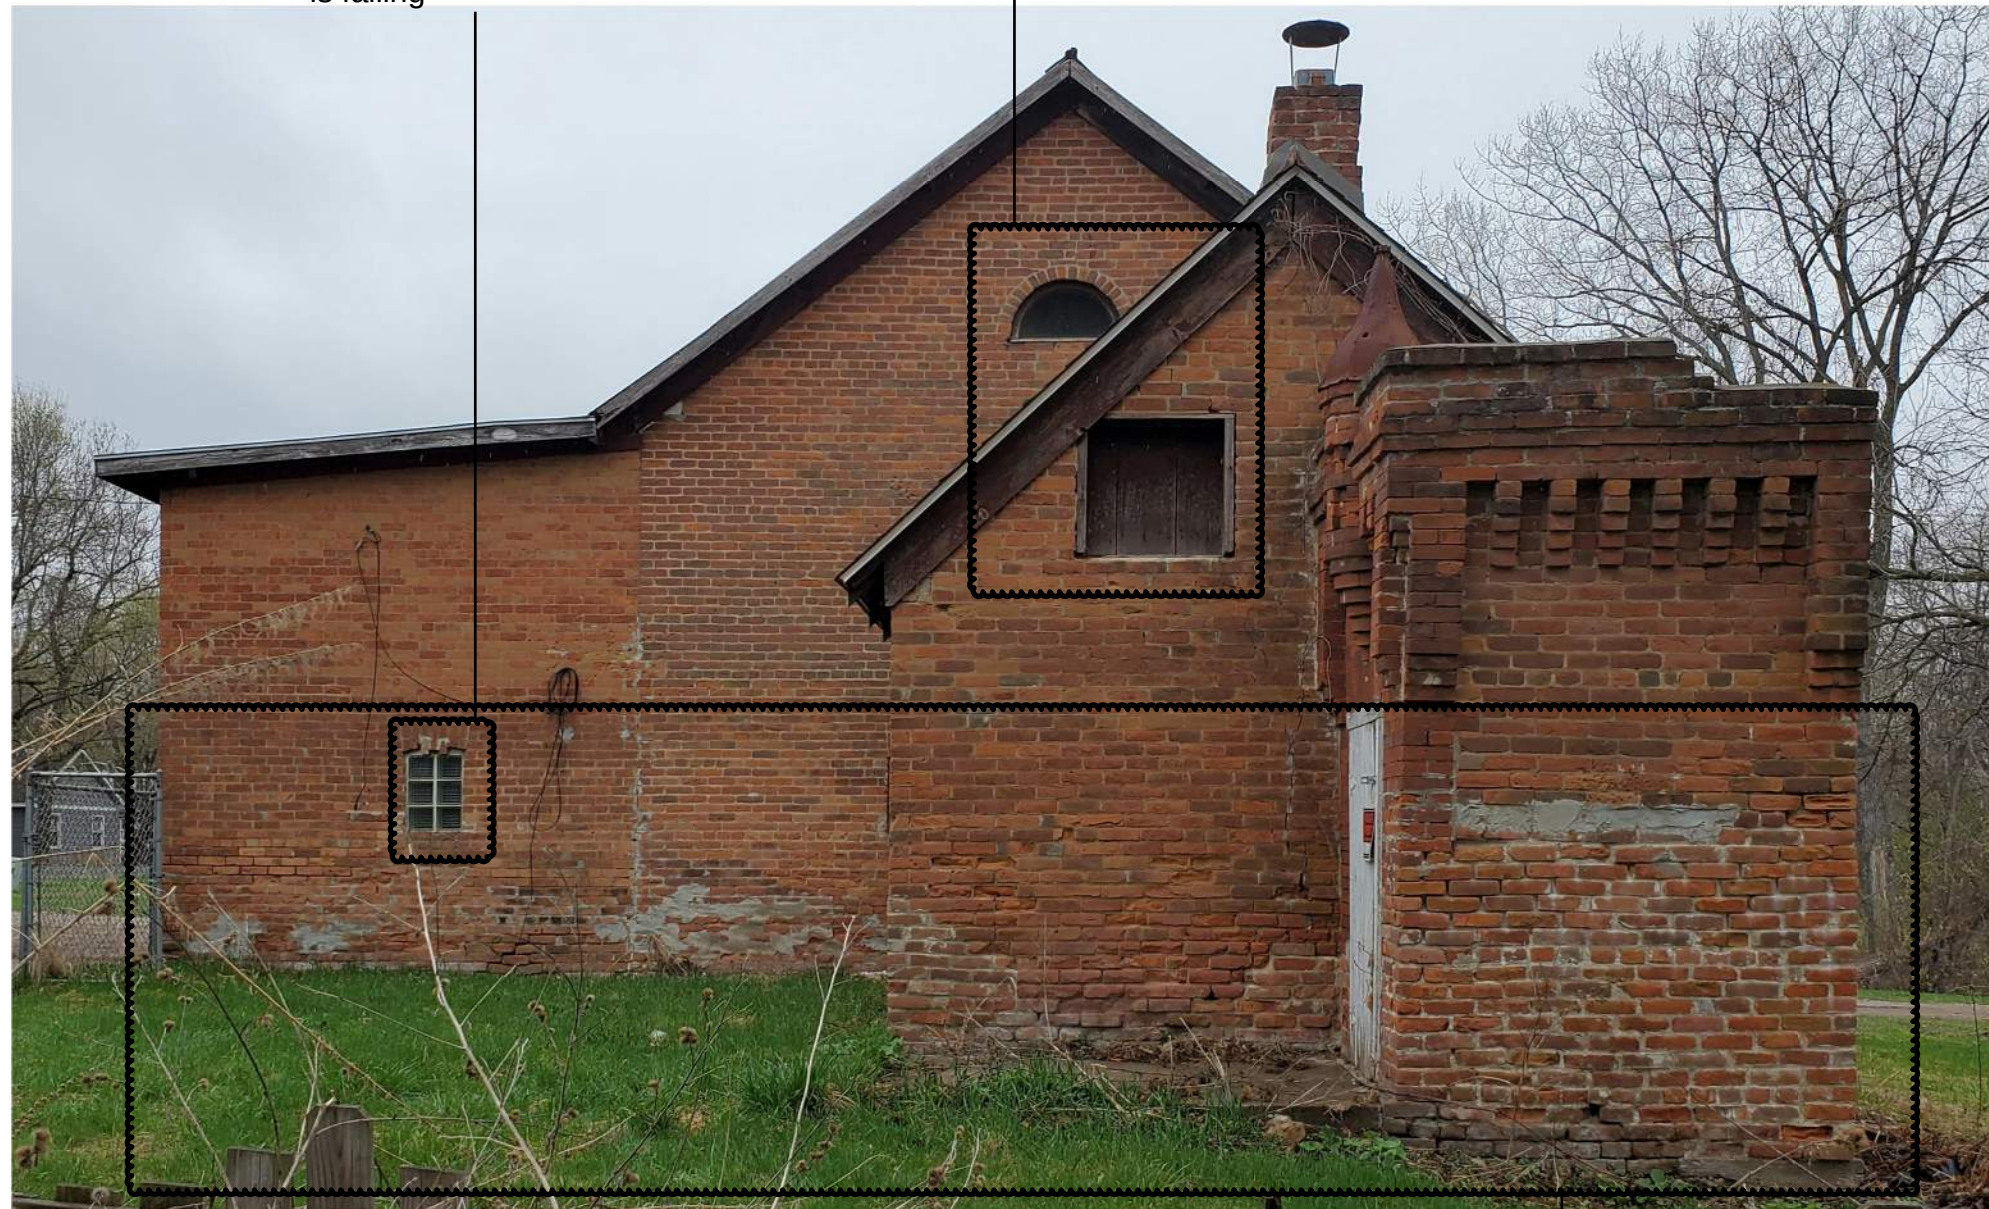
SHEET **AP215** Miller  
Dunwiddie  
EXTERIOR ELEVATION EAST WORKSHOP  
04/20/21

Glass block at brick  
arched opening. Arch  
is failing

Plexiglass and wood  
infill at openings

See AP212 for  
masonry notes
