Schroeder House

City Council

1/16/2023

SCHROEDER HOUSE RESTORATION

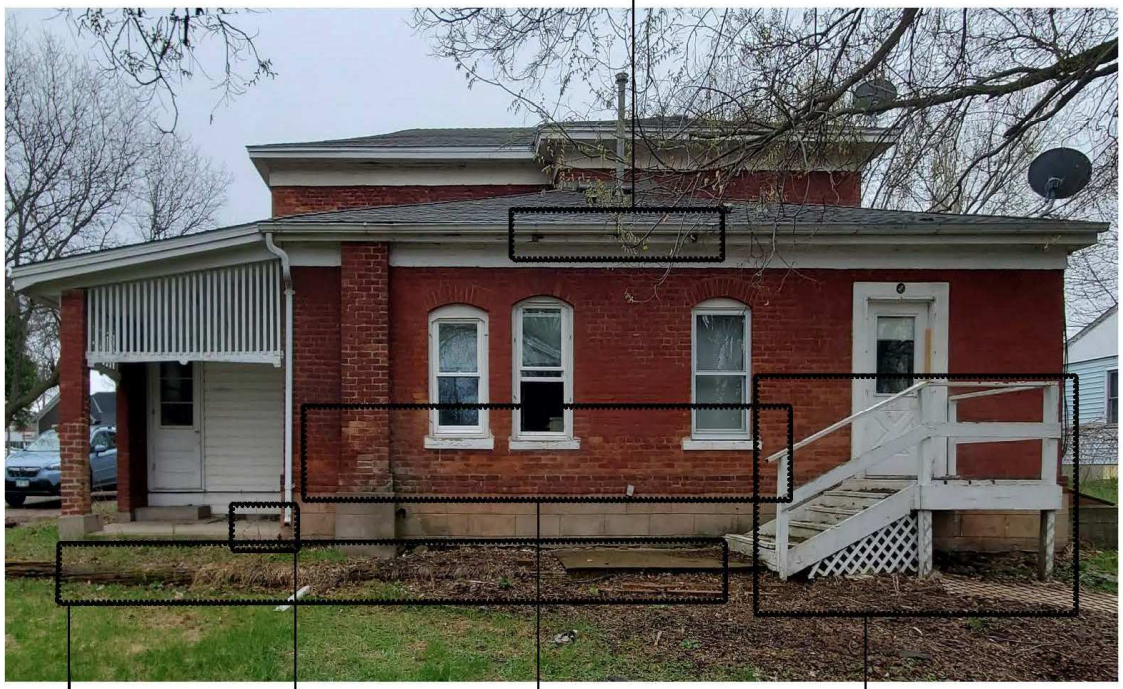
SHEET **P202**

REPOINT/REPLACE BRICK

REVIEW GUTTER CONDITION - REPAINT/REPLACE FASCIA AS REQUIRED

CORRECT GRADING. POTENTIAL FOR AT GRADE SEATING AREA

REPLACE CONCRETE SLAB

REMOVE STAIR - POTENTIAL TO REBUILD WITH OUTDOOR SEATING AREA
