Report of Inspection Procedures and Results for  
Determining Qualifications of a  
Tax Increment Financing District as a Redevelopment District

## Canterbury Park Redevelopment TIF District Shakopee, Minnesota

April 30, 2019

**City of Shakopee**

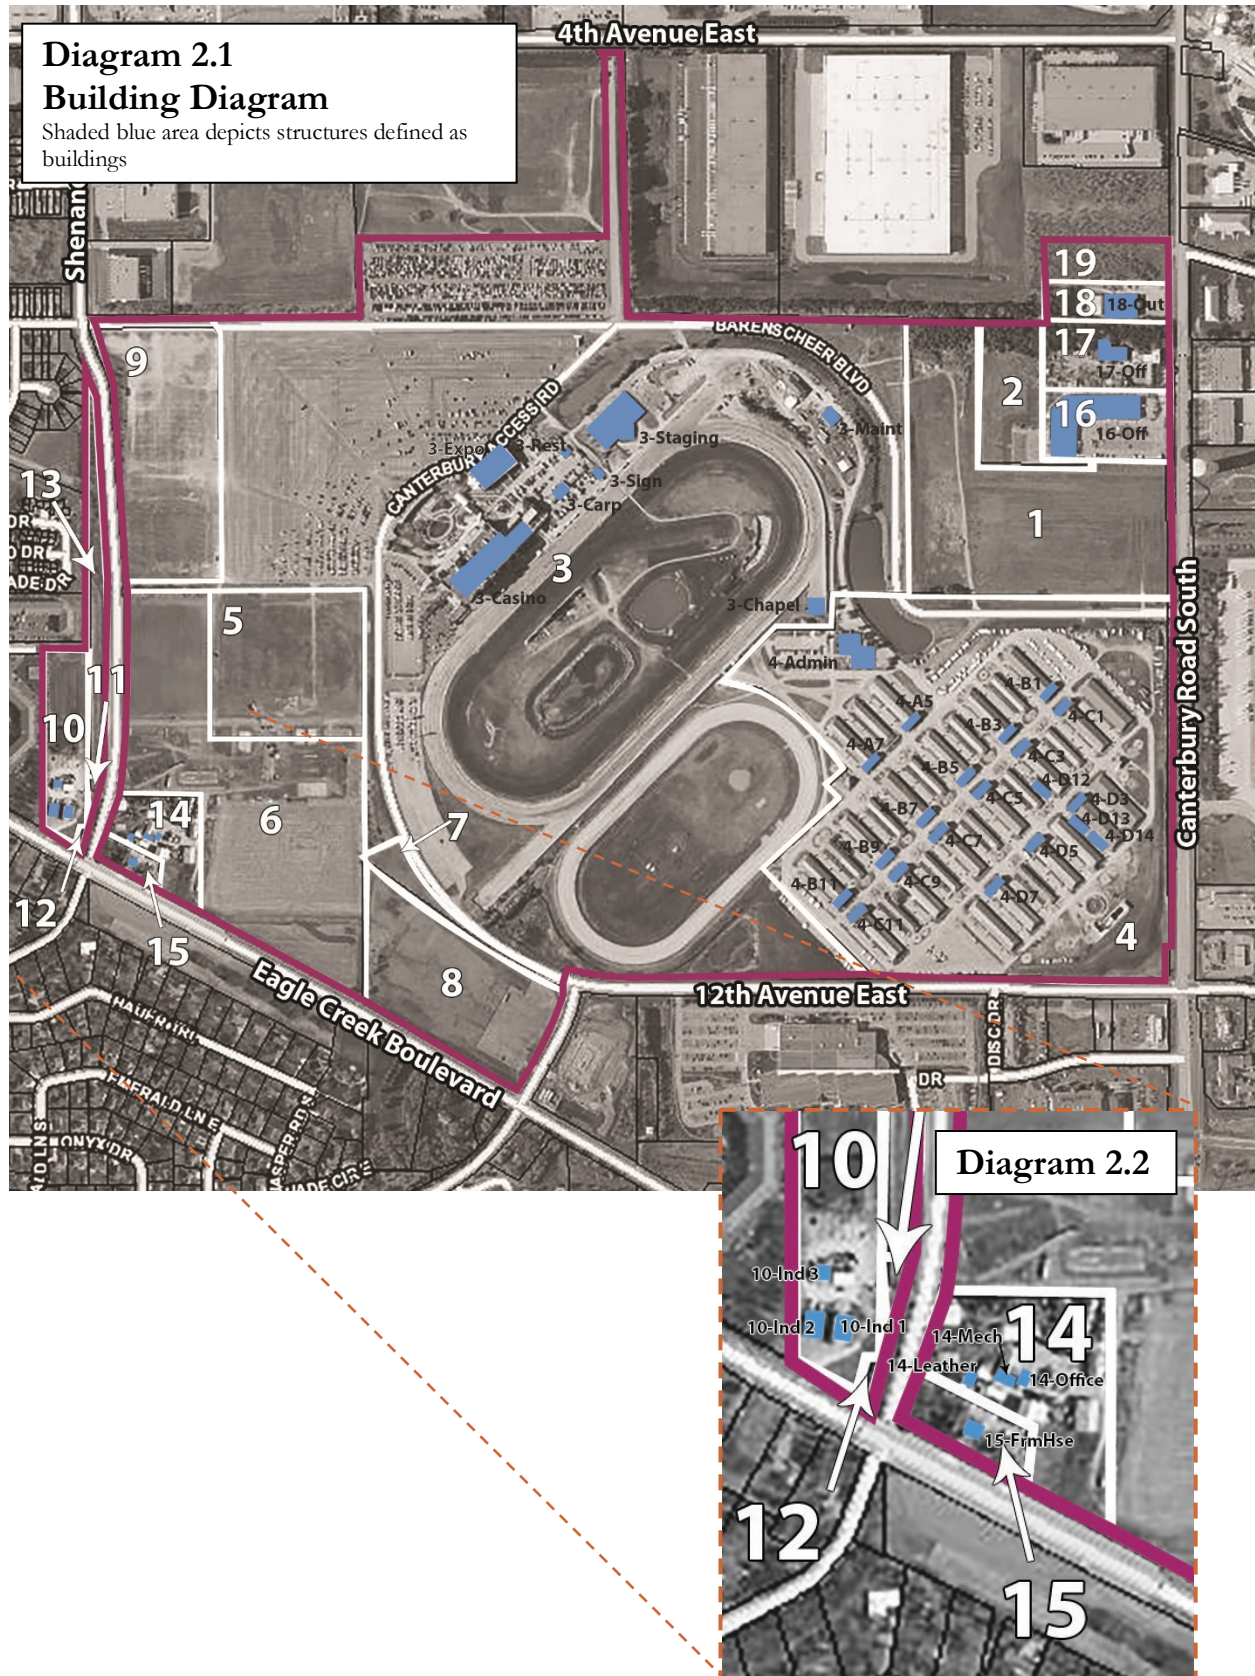
For the purposes of our work, we are defining buildings as those structures inhabited by human beings (Diagram 2). These structures would typically include water, sewer and electricity. Barns and small storage facilities are considered “outbuildings” which are not typically considered in TIF analysis because they have very few code requirements and are not intended for human occupation.

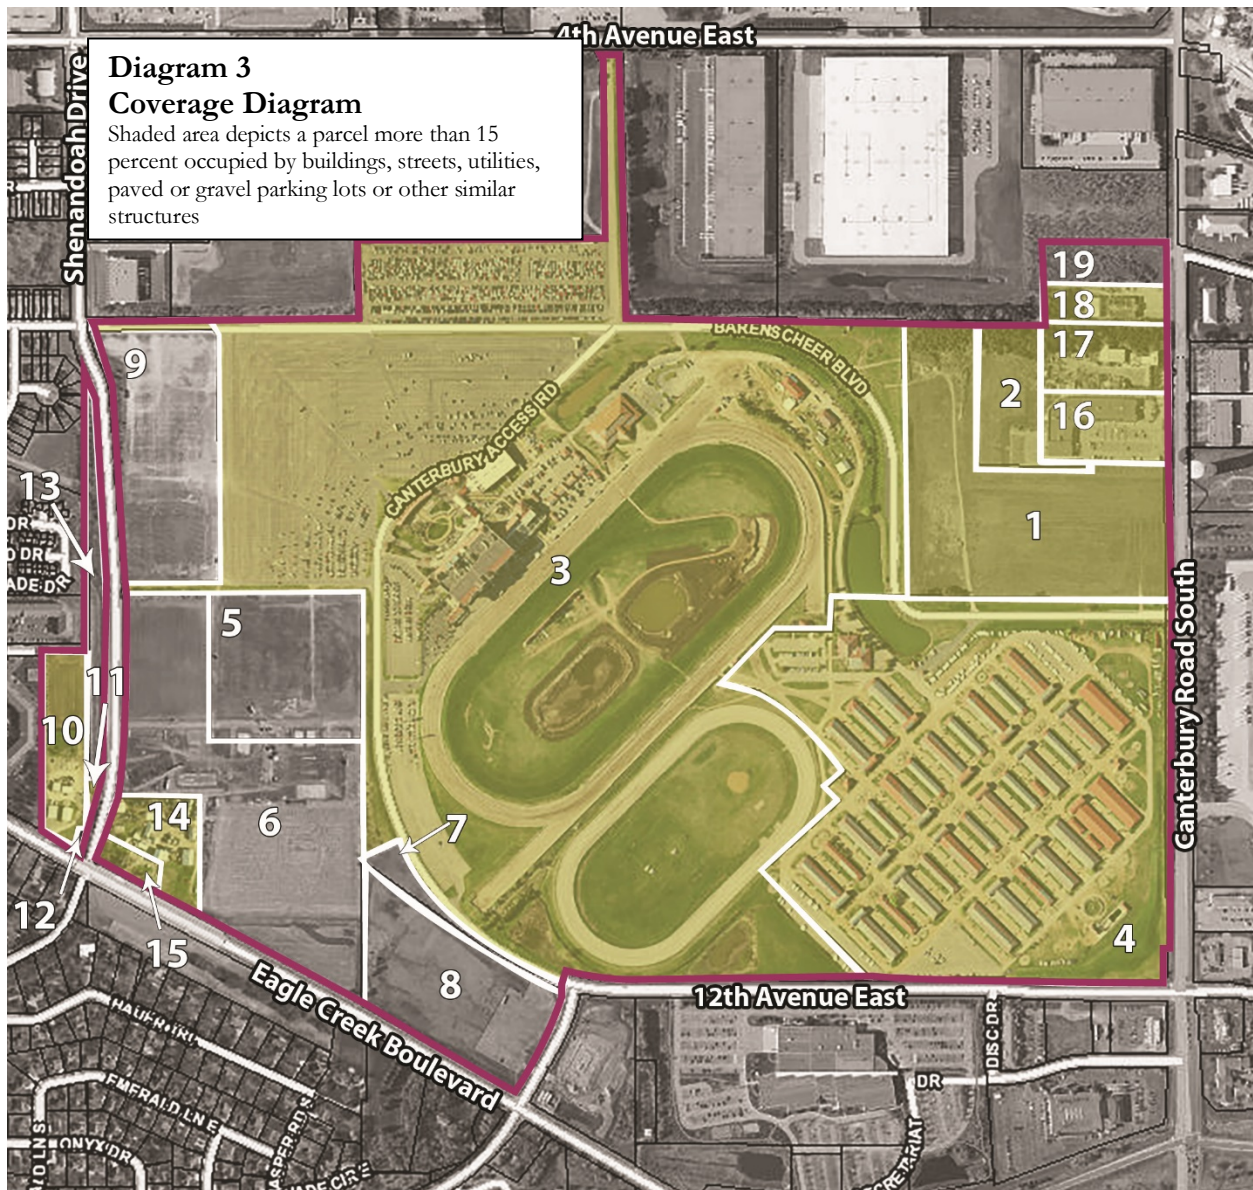
The proposed TIF District met the coverage test under *Minnesota Statutes, Section 469.174, Subdivision 10(e)*, which resulted in parcels consisting of 81.3 percent of the area of the proposed TIF District being occupied by buildings, streets, utilities, paved or gravel parking lots, or other similar structures (Diagram 3). This exceeds the 70 percent area coverage requirement for the proposed TIF District under *Minnesota Statutes, Section 469.174, Subdivision (a) (1)*.
