Report of Inspection Procedures and Results for  
Determining Qualifications of a  
Tax Increment Financing District as a Redevelopment District

## Shakopee Riverfront Bluff Redevelopment TIF District Shakopee, Minnesota

April 30, 2019

Prepared For the  
**City of Shakopee**

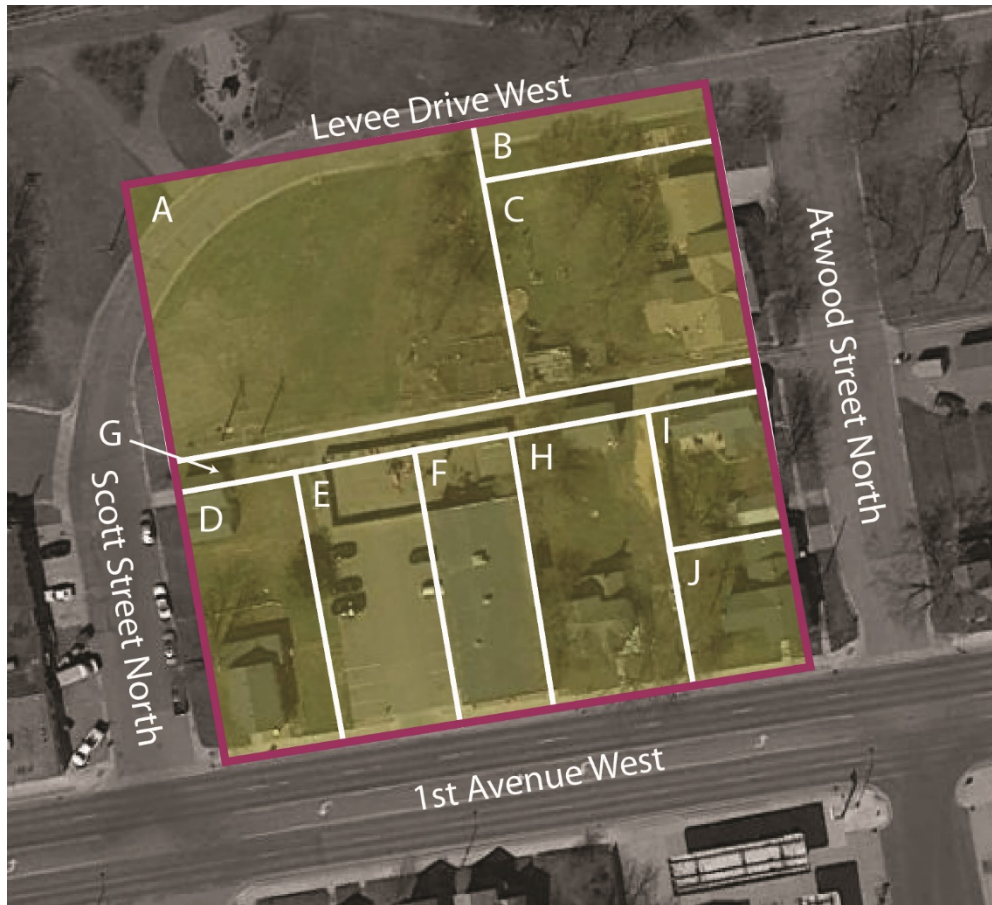
**Diagram 2 – Coverage Diagram**

Shaded area depicts a parcel more than 15 percent occupied by buildings, streets, utilities, paved or gravel parking lots or other similar structures

The proposed TIF District met the coverage test under *Minnesota Statutes, Section 469.174, Subdivision 10(e)*, which resulted in parcels consisting of 100 percent of the area of the proposed TIF District being occupied by buildings, streets, utilities, paved or gravel parking lots, or other similar structures (Diagram 2). This exceeds the 70 percent area coverage requirement for the proposed TIF District under *Minnesota Statutes, Section 469.174, Subdivision (a) (1)*.

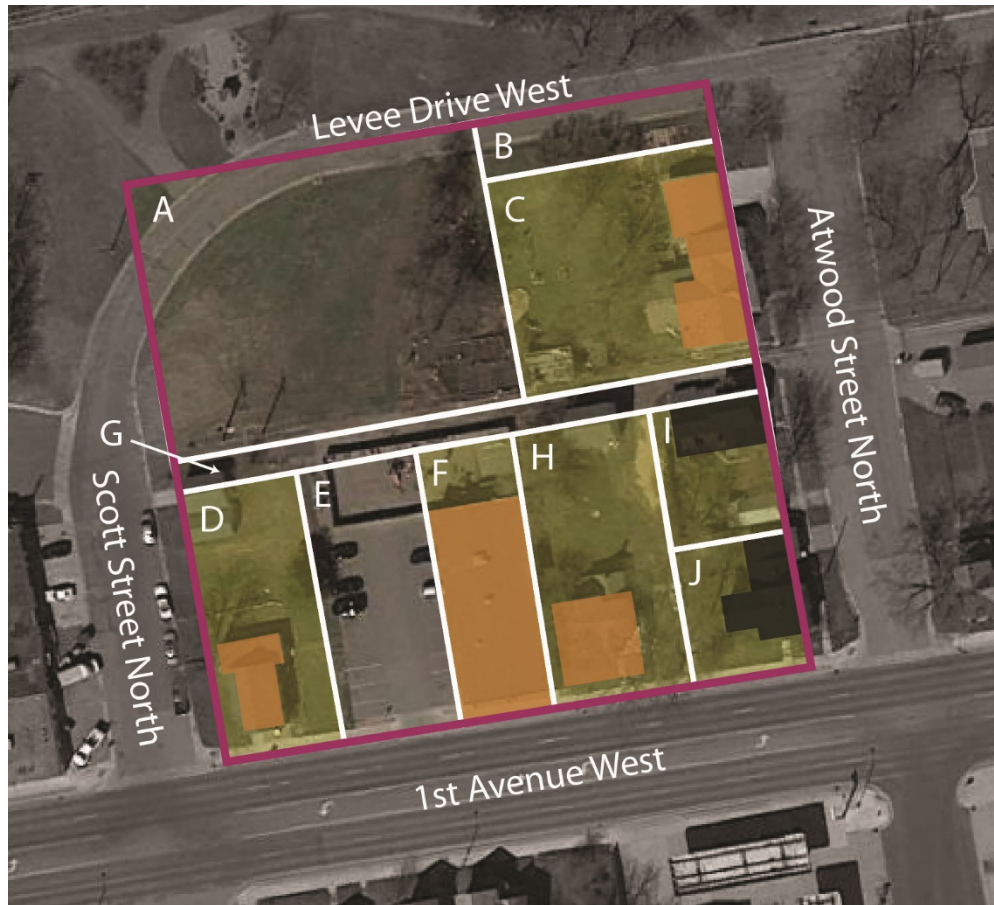
**Diagram 3 – Substandard Buildings**  
 Shaded green area depicts parcels with buildings.  
 Shaded orange area depicts substandard buildings.

The parcels with substandard buildings are reasonably distributed compared to all parcels that contain buildings.
